DEPARTMENT OF TRANSPORTATION**DIVISION OF ENGINEERING SERVICES**

Quality Assurance and Source Inspection

Contract #: 04-0120F4Cty: SF/ALA Rte: 80 PM: 13.2/13.9File #: 50.15**SOURCE INSPECTION REPORT****Resident Engineer:**Pursell, Gary**Address:** 333 Burma Road**City:** Oakland, CA 94607**Report No:** SIR-001725**Date Inspected:** 04-Feb-2010**Project Name:** SAS Superstructure**OSM Arrival Time:** 700**Prime Contractor:** American Bridge/Fluor Enterprises, a JV**OSM Departure Time:** 1900**Contractor:** Zhenhua Port Machinery Company, Ltd (ZPMC), Jiangyin**Location:** Chang xing dao, Shanghai**Quality Control Contact:** Mr. Don walton**Quality Control Present:** Yes No**Material transfer:** Yes No N/A**Sampled Items:** Yes No N/A**Stock Transfer:** Yes No N/A**OK to Cut:** Yes No N/A**Rebar Test Witness:** Yes No N/A**Delayed/Cancelled:** Yes No N/A**Other:** Coatings Inspection**Bridge No:** 34-0006**Component:** See below**Bid Item:** 77, 78, 79**Lot No:** B #204**Summary of Items Observed:**

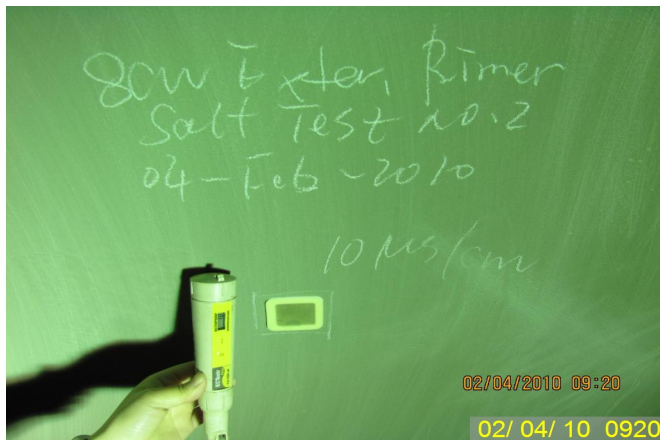
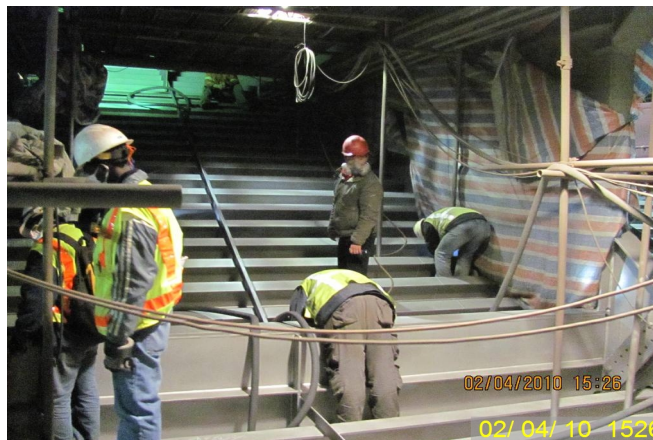
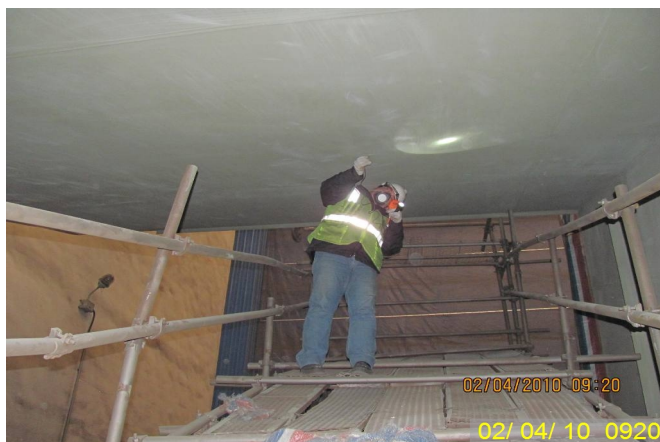
An inspection was requested for the OBG segment, 7EW, internal entire floor from the weld seam to p.p60 to p.p59 for the visual inspection after Pre blasting, vide request no. 2616 at Blasting shop 1. This Caltrans inspector observed, ABF inspectors Mr. Don waltom performing visual inspection of weld repairs, Spatters, porosity etc. Caltrans Inspectors Mr. Tim mclandon, Mr. Larry viars, Mr. Bera, Mr.Chandra were present for marking these defects during this inspection.(Photo attached). The ambient conditions found to be 5.7 deg. above dew point and the relative humidity found to be 53.4% inside the paint shop which is found to be within the parameters of contract documents.

An inspection was requested for the OBG segment, 8CW, external surface for residual chlorides test, MEK test and DFT check of external Interzinc 22 applied areas, reuest no. 2613 at Painting shop 2. This Caltrans inspector observed, ABF inspectors Mr. Sun, Mr. Jiang huan, Mr. Zhou wei and Mr. Shi stone performing above mentioned inspections.(Photo attached) Residual chlorides test conducted by ZPMC and the results were found to be 10 us/cm and 20 us/cm which is acceptable as per contract documents.(Photo attached). DFT and surface preparation inspected by ABF Inspectors and found within the requirement of contract documents. The results of MEK test for Interzinc 22 curing found to be in the grade 4 which require further curing, hence this MEK test results were found rejected by ABF Inspectors. The same segment were offered for MEK test vide Inspection

request no. 2615 .The ambient conditions found to be within the parameters of contract documents. International protective coating technical service representative Mr. Peng Zi li was in attendance during the inspection process.
